PROFESSIONAL RESERVE STUDY

LakeLand Village

470 East Country Club Drive, Allyn, WA 98524

June 8, 2020

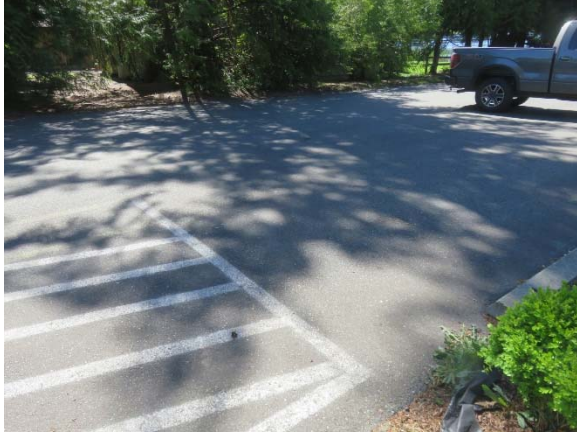
The Association does own the parking lot adjacent the north beach area and the asphalt cart path on the west side of Lake Anderson. We understand that some asphalt repairs were performed on the cart paths in 2026. We have budgeted for asphalt repairs of the cart paths and parking lot every 10 years and seal coating and restriping of the parking lot only every 5 years.

Asphalt Parking Lot at North Beach Area

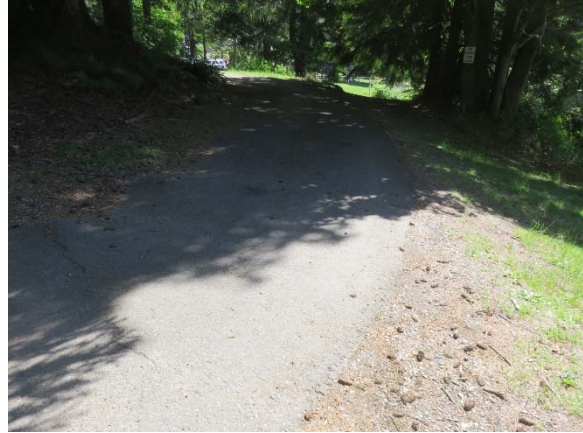
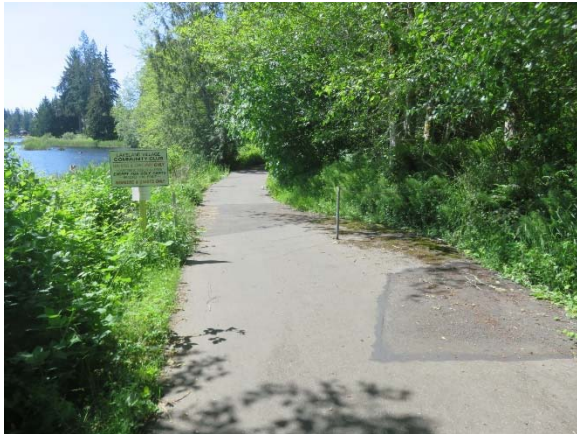
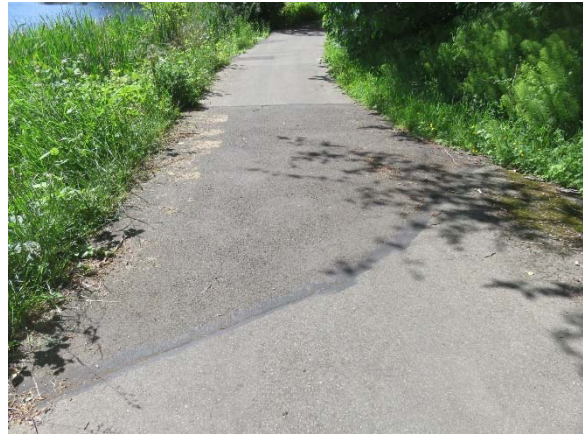
Asphalt Cart Path

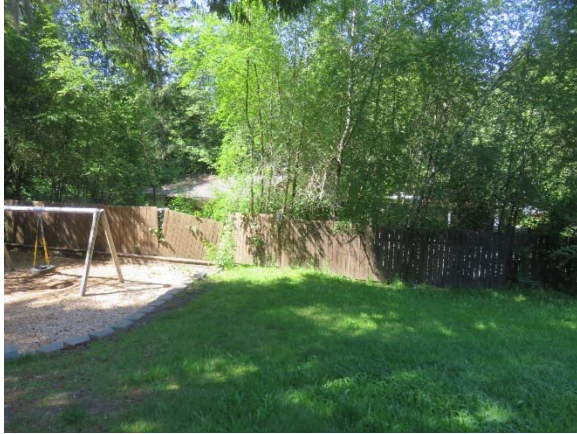
There is a privacy fence adjacent the playground area that is in need of some repairs at this time. We understand that this maintenance will be performed by HOA members. We have assumed that the fences will be stained and have spot railing replacement by volunteers or via the general operating budget. If such maintenance is performed, then we believe that this fence should have a remaining lifespan of 10 years. Once replaced, we have assumed a total lifespan of 25 years with maintenance.

Wood Fence Adjacent Playground

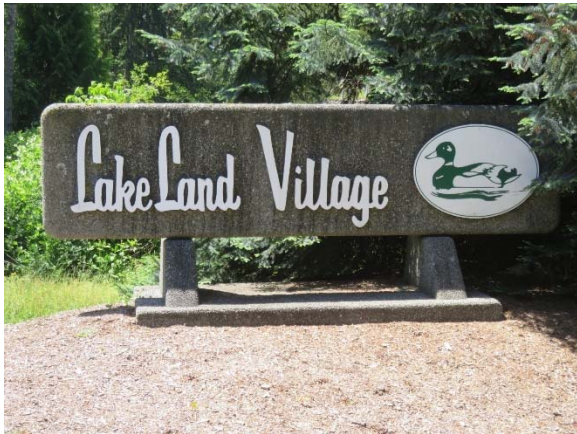
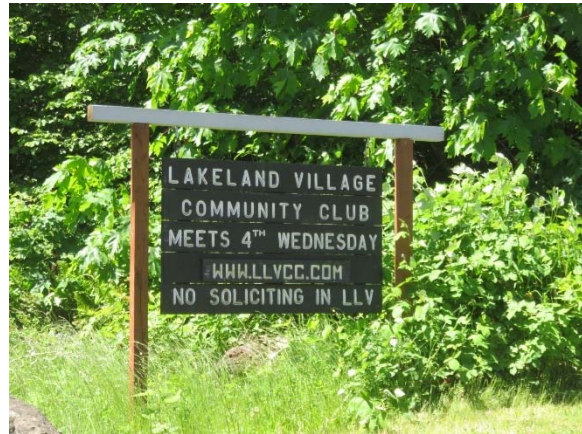
There are two large signs that we understand are owned by the Anderson family and are not maintained by LLVCC. There is a smaller property sign (shown below on the right) that is owned by LLVCC. This sign is very simple and has not been budgeted for replacement in this study.

Property Sign

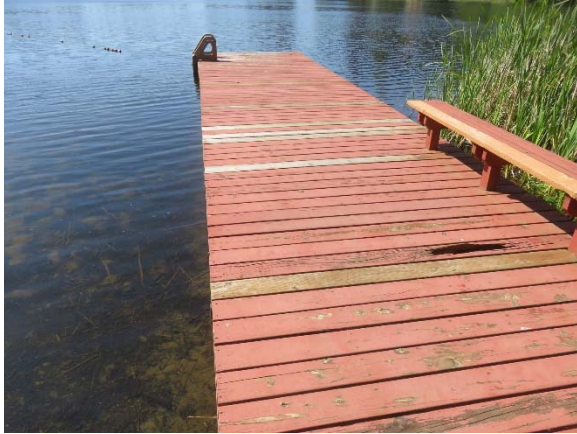
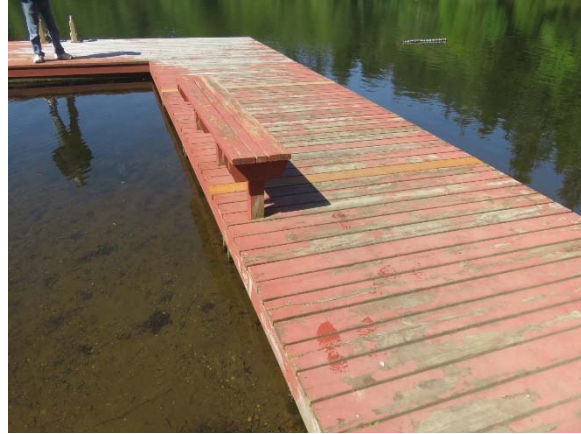
The Association owns 6 docks on Lake Anderson including two swimming docks and a fishing dock at the north end of the lake, two floating fishing docks at the south end of the lake, and a dock at the boat ramp. We understand that the boat ramp dock was rebuilt in 2015. We have budgeted for replacement of the rest of these docks in 2030 and every 40 years thereafter.

One of Two Swimming Docks at the North End of the Lake

Two of Two Swimming Docks at the North End of the Lake

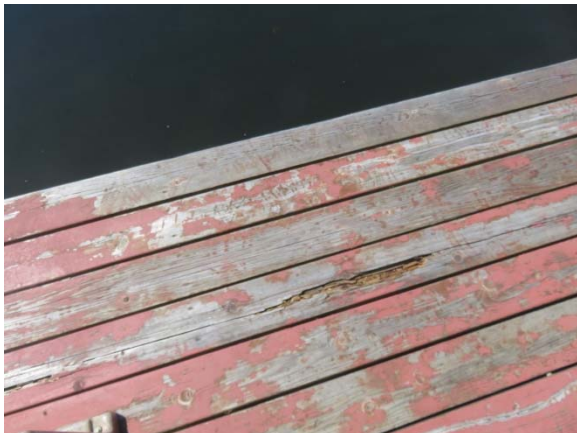
Typical Rot Damage in Decking

We understand that rotten decking is replaced as necessary via the general operating budget.

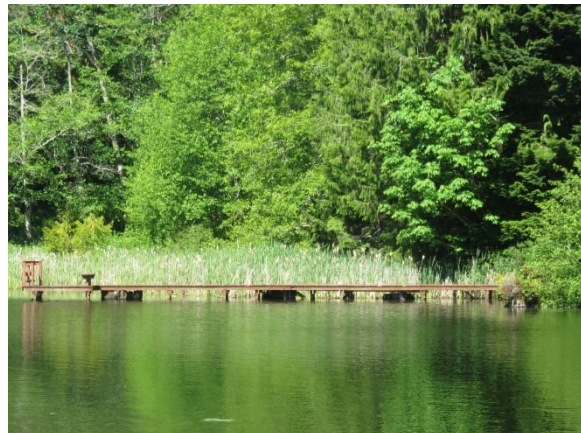
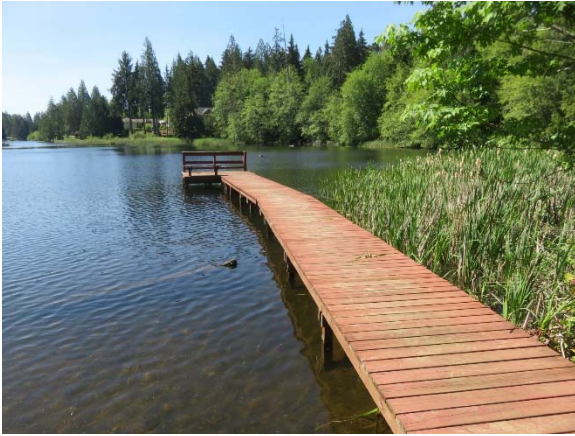
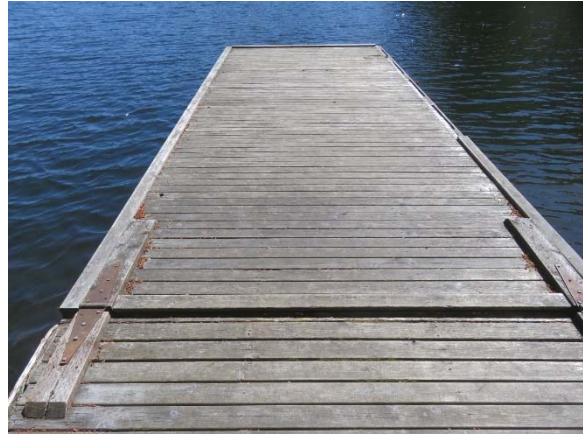
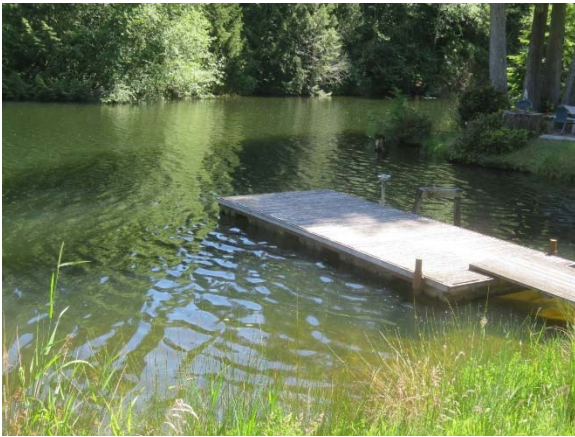
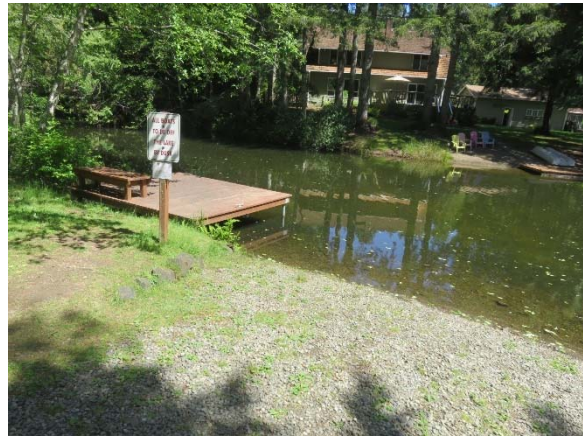
Fishing Dock at the North End of the Lake

One of Two Fishing Docks at the South End of the Lake

Two of Two Fishing Docks at the South End of the Lake

Dock at the Boat Launch

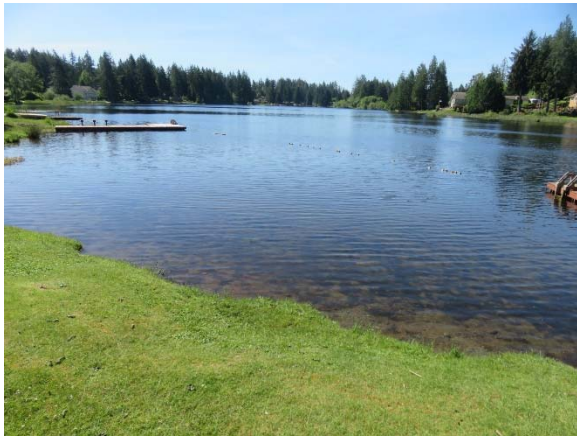
There is a swimming beach at the north end of the lake. No Reserve Funding is anticipated to be necessary to maintain this swimming beach

Swimming Beach

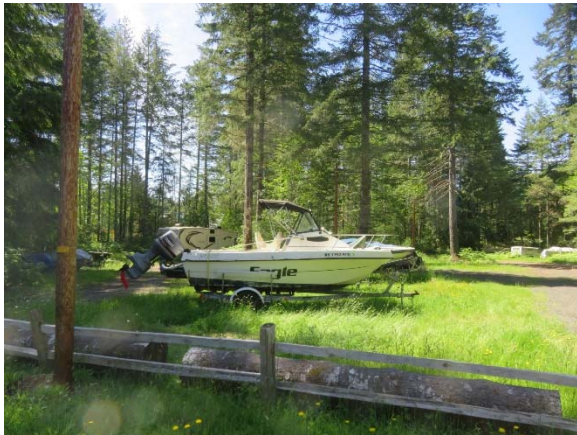
There is a boat storage lot at the south end of the lake. We understand that this boat storage lot may be converted into a park in the future; however, this has not been voted on and no funding has been budgeted for this project at this time.

Boat Storage Lot

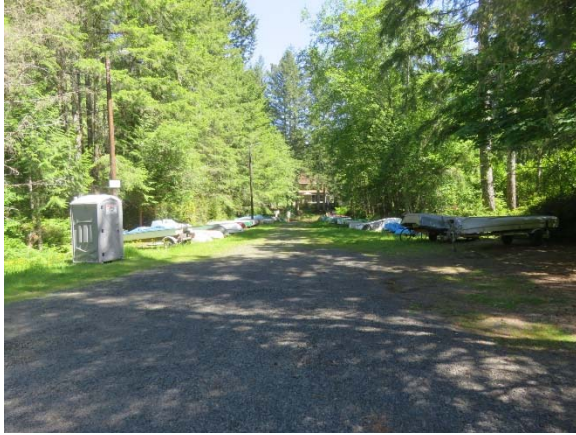
There is a boat launch at the south end of the lake. We do not anticipate any Reserve Funding to be necessary at this boat launch within the next 30 years.

Boat Launch

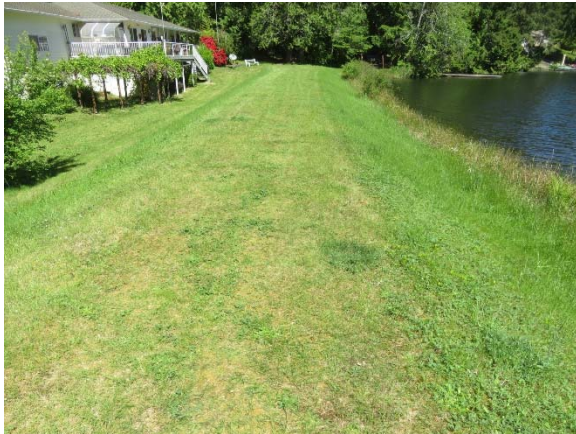
Lake Anderson is a man-made lake that was created in the 1960s and is approximately 55 acres. There is an earth dam at the southwest side of Lake Anderson. This is a very low maintenance dam and the only maintenance that is anticipated is the eventual replacement of the slide gates. We understand that the main slide gate was replaced in 2013, while the auxiliary slide gate is original from the 1960s. We believe that this dam should have a lifespan well beyond the duration of this study; as many earth dams have lifespans well beyond 100 years. Therefore, we have not budgeted for replacement of this dam in the Reserve Study.

Earthen Dam

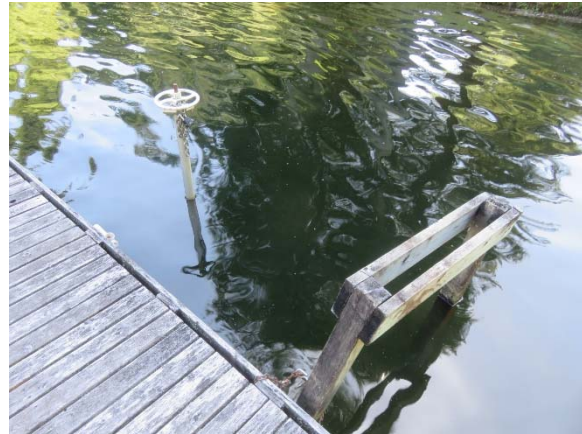
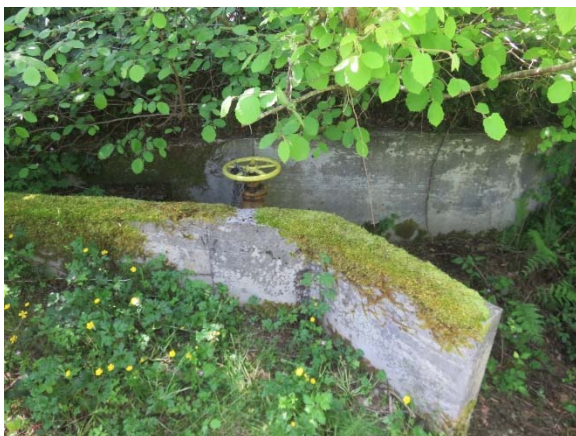
We have assumed that the slide gates will have a total lifespan of 40 years. We have budgeted for replacement of the auxiliary slide gate in 2023 at a lower cost to replace than the main slide gate, as the area should not need to be dewatered. These slide gates should be exercised annually to ensure that they are functional.

Main Slide Gate

Auxiliary Slide Gate

We recommend that the slide gate be inspected in 2023 and every 10 years thereafter by a marine structural engineer. Additionally, we recommend that this marine structural engineer perform an underwater inspection of all of the docks.

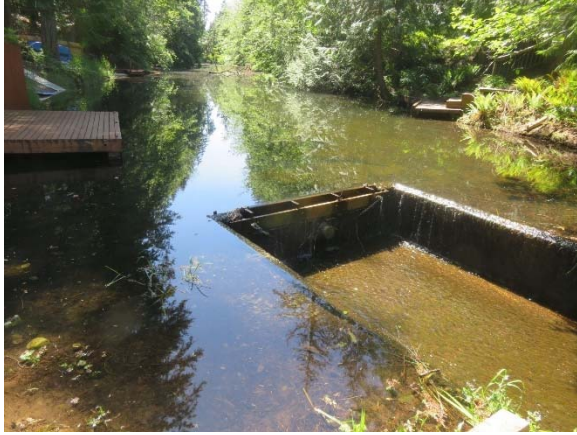
There is a concrete and wood weir at the end of the outfall of this lake that controls the elevation of the lake. We understand that this weir is repaired as necessary by the Board and members of the community. Therefore, no Reserve Funding has been budgeted for maintenance of this weir.

Weir

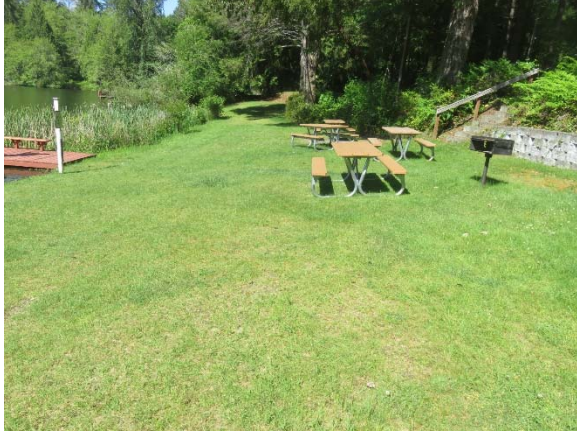
There are picnic tables, benches, and barbecues in this property that are owned by the community. We have budgeted for a “picnic assets allotment” every 5 years for purchase of additional items or repair of the current picnic assets.

Typical Picnic Tables

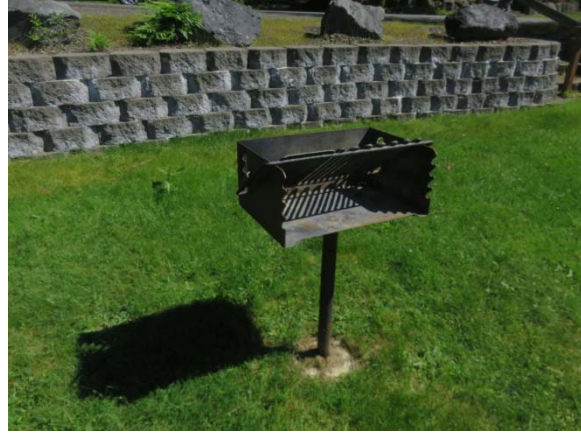
One of Two Barbecues

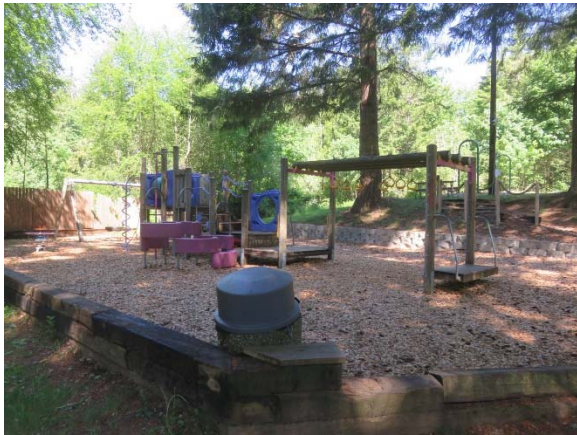
There is a playground set near the north beach area that is older, but is in relatively good condition. A new slide and hold bar were just installed on the playground. We have budgeted for this playground set to be replaced in 2030 and every 25 years thereafter, as that is the typical lifespan of these playsets (though this one has obviously had a longer life).

Playground

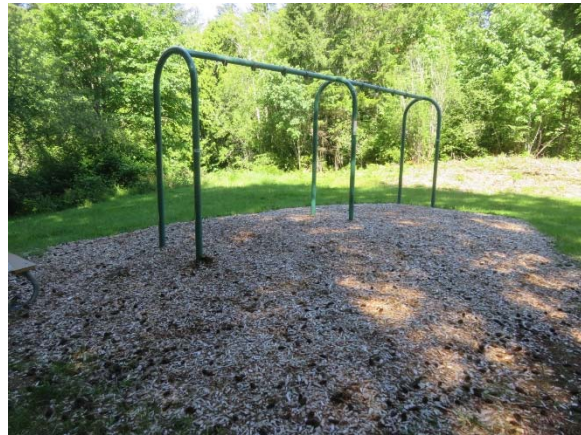
There is also a new swing set at this playground area that was just installed at a cost of \$16,500 in 2018. As this is a steel structure with durable components, we assume that this swing set will have a total lifespan of 30 years, with maintenance.

Swing Set

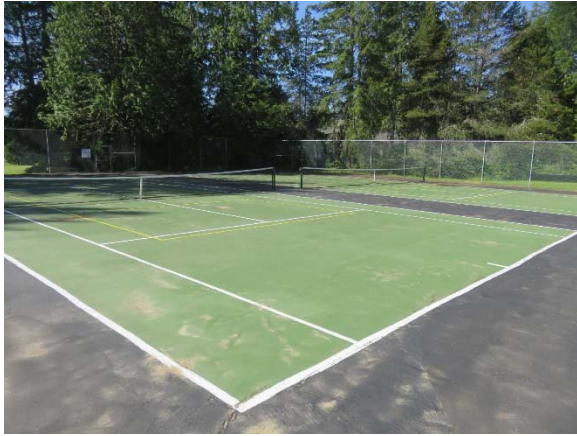
The tennis courts are not owned by the LakeLand Village Community Club; however, the LLVCC does pay for resurfacing of these tennis courts, as it was just resurfaced in 2019. We understand that the cost of the materials for the tennis court resurfacing was approximately \$8,000 and it was applied by volunteers in the community. This is the plan going forward and we have assumed that resurfacing will occur every 10 years.

Tennis Court

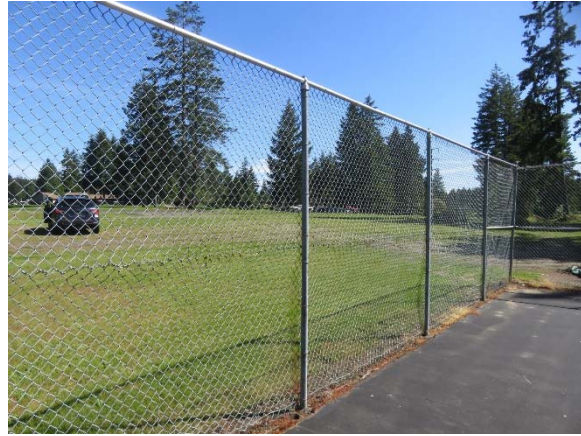
Fence Surrounding Tennis Court

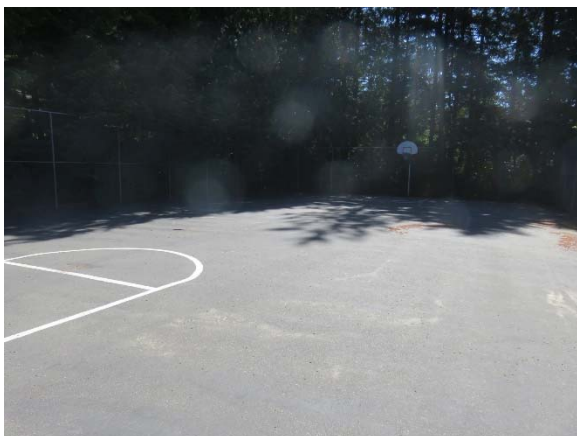
There is a basketball court in this Association. There is not a professional surface on this court and it is typically striped by volunteers as necessary. We have assumed that there will not be any significant Reserve Fund expenditures associated with the basketball court.

Basketball Court

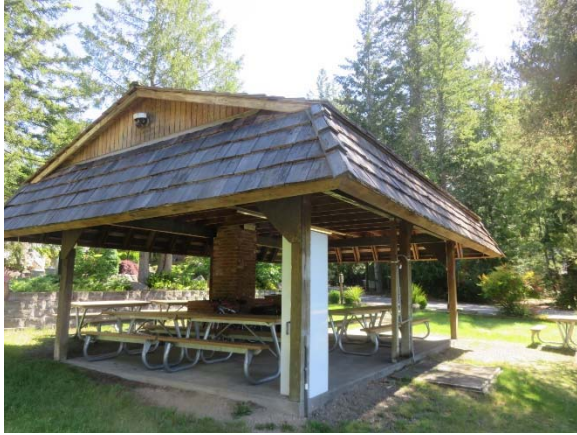
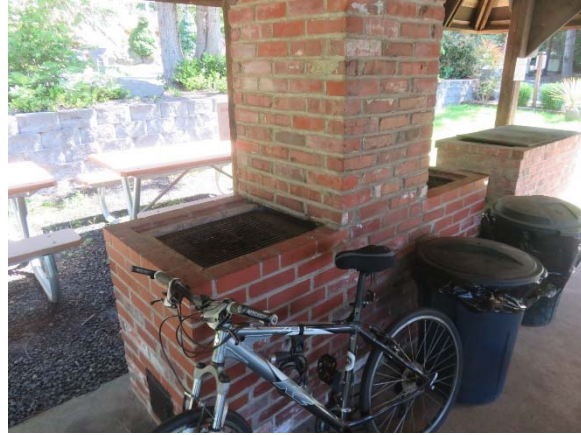
There is a picnic shelter at the north beach area that contains brick barbecues and a concrete slab. There are several picnic tables under this picnic shelter. We understand that the wood shake roof was installed in 2010; we have assumed an 18-year life for this wood shake roof surface and have assumed like-kind replacement. The brick barbecue was cleaned up and repaired around 2018; we have assumed that this will be necessary every 10 years.

Picnic Shelter

Barbecue in Picnic Shelter

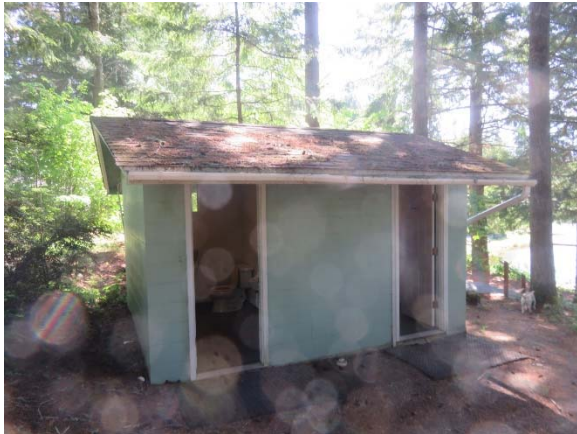
There is a community bathroom building adjacent the playground with two separate bathrooms with an asphalt composition roof surface. We have budgeted for resurfacing of the roof every 25 years. We understand that painting and all other maintenance of this building will be done by volunteers with materials paid for outside the Reserve Fund.

Bathroom House

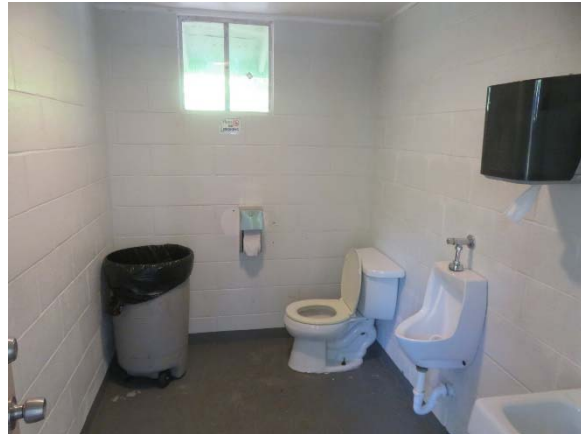
Inside of One of the Two Bathrooms

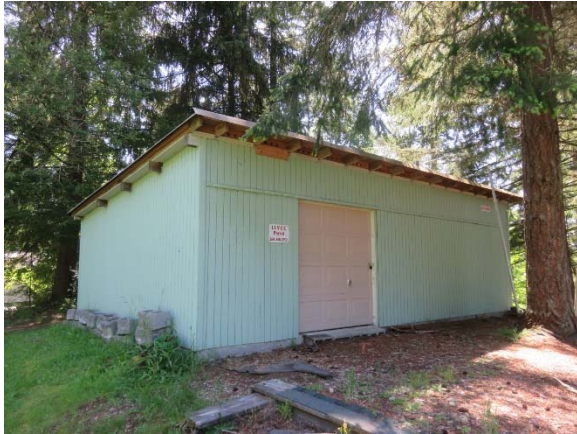
There is a maintenance shed with a roll roofing surface. We have budgeted for resurfacing of the roof every 15 years. We understand that painting and all other maintenance of this building will be done by volunteers with materials paid for outside the Reserve Fund.

Maintenance Shed

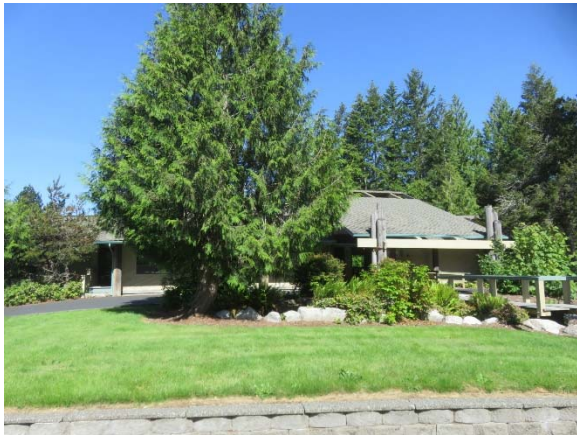
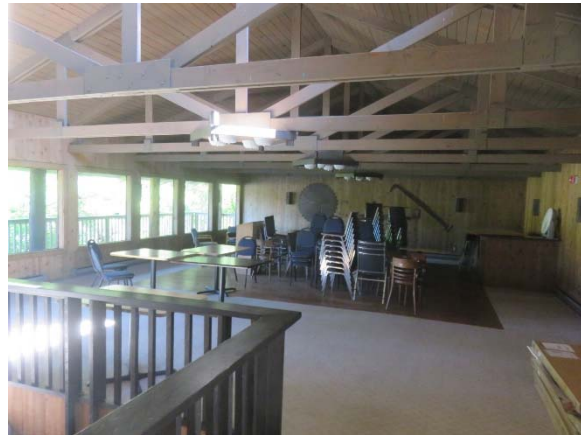
The clubhouse is not owned and maintained by LakeLand Village Community Club. Rather an office space is leased.

Exterior of Clubhouse

Interior of Clubhouse

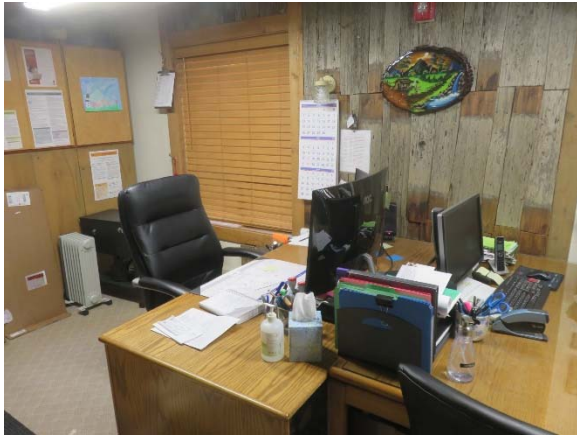
While the office in the clubhouse is leased, the computer equipment is owned by the Association. Therefore, we have budgeted for an office computer allotment every 5 years.

Office

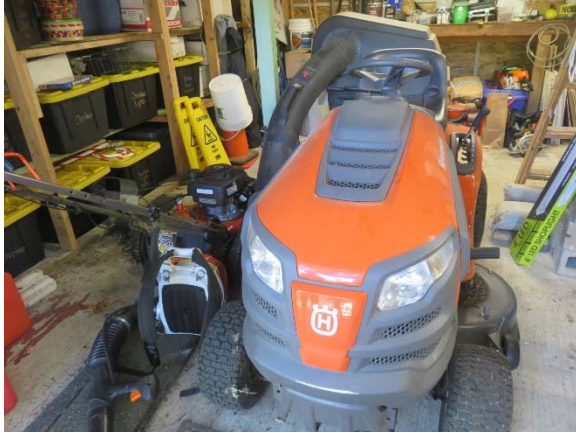
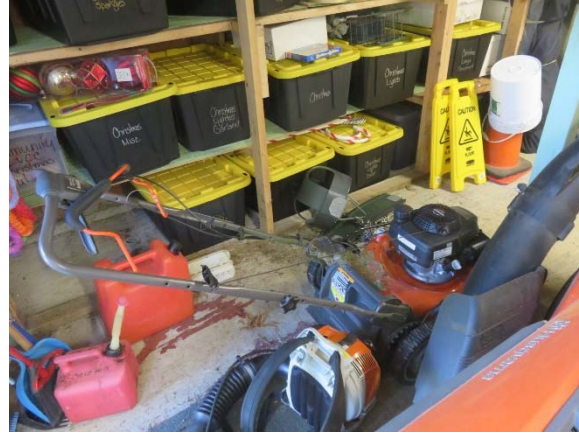
The Association owns a riding lawn mower and a push mower that are both approximately 3 years old. We have assumed that both of these pieces of equipment will have a total lifespan of 10 years. Additionally, we have budgeted for a general maintenance tool allotment for replacement/repair of smaller tools every 5 years.

Riding Lawn Mower

Push Mower
